Orbit Newsletter Digital Publication

Q2 2020

Radial rub at centrifugal compressor's ISO carbon seals

Juan Carlos Ustiola, Vibration Specialist (CAT III)
Hwang Wootae, Rotating Equipment Engineer

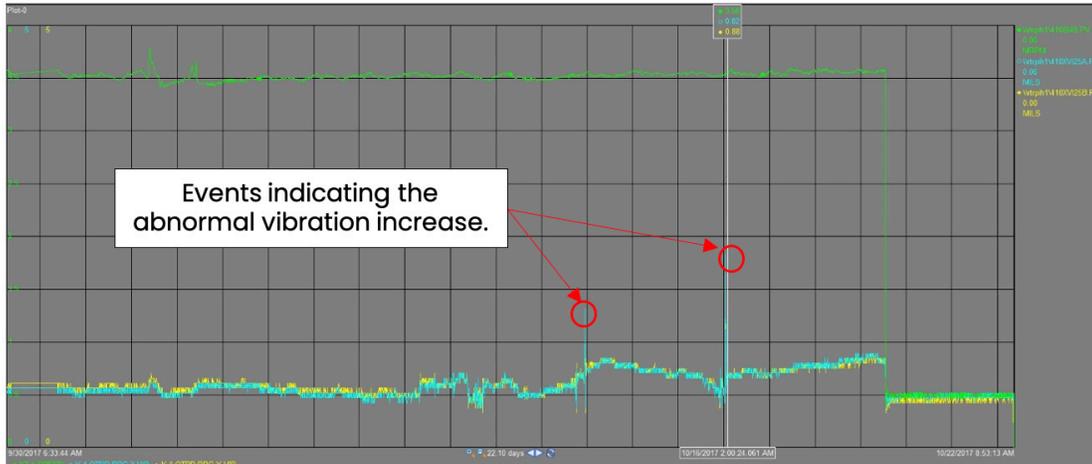
In October 2017, a vibration level increase was noticed on the compressor at the outboard bearing close to 2 mils (Fig 2). During that opportunity the dynamic data was analyzed identifying a possibility of rub in that compressor's area. During a maintenance window it was decided to inspect the bearing and replace them due to Babbitt deterioration caused by the ingress of water (found in the lube oil sampling report) and solid particles in the lube oil.

Figure 2. PI Trend (Speed, Outboard bearing Vibration Ch. X, Y). First symptom of rub.

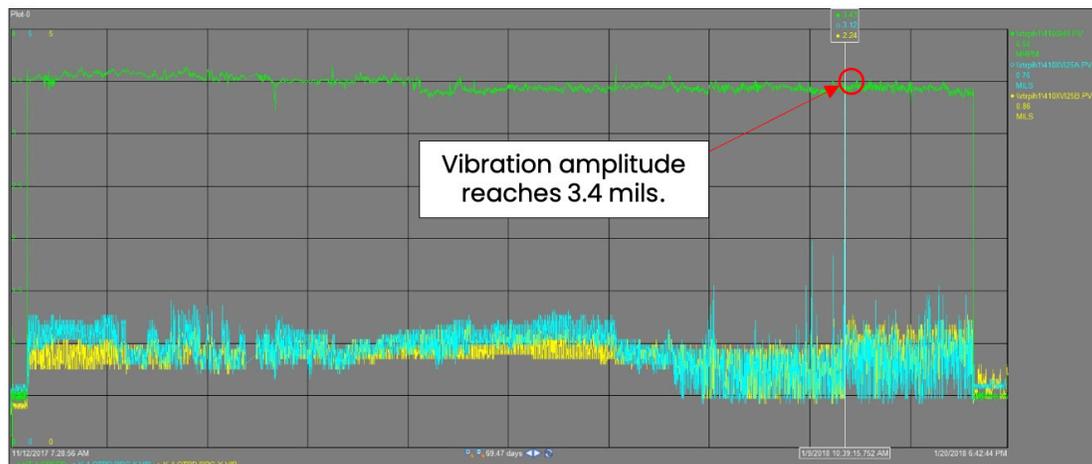
The compressor was back on service on November 2017 and after two months of operation it started to behave in a similar way as previously, but in that case with more frequent vibration events, exceeding this time 3 mils (Fig 3).

Figure 3. Trend (Speed, Outboard bearing Vibration Ch. X, Y). Advancing the vibration problem.

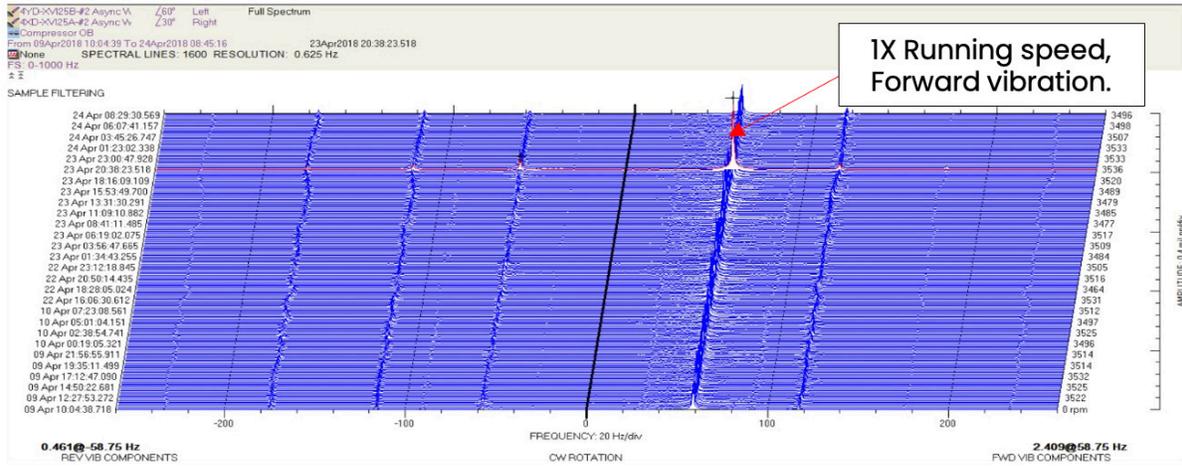
The predominant amplitude during the vibration event was noticed at the compressor running speed (1X Frequency) in steady state, as it can be observed in the below full spectrum waterfall plot (Fig 4). To investigate the potential root causes affecting the vibration response, it was required to dig down in other plots to explore the nature of the problem.

Figure 4. Full spectrum Waterfall Plot at 410 K1 Outboard Bearing.

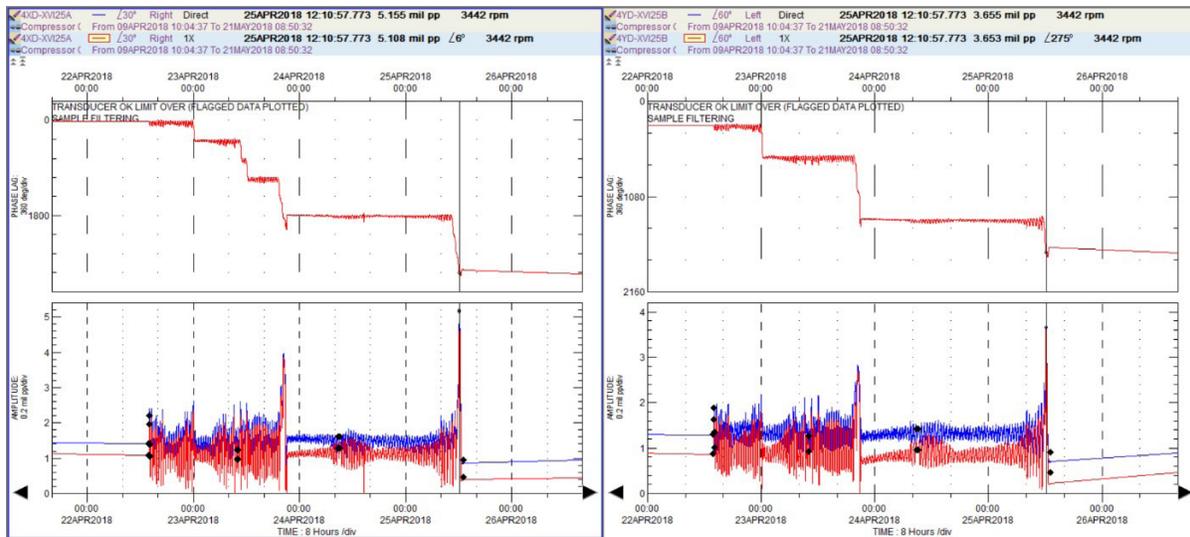
The overall vibration and 1X amplitude was aggravating as the time passed. A five (5) days compressor trend was pulled out from the data collector in the outboard bearing (Fig. 5). The trend displays how this phenomenon became more repetitive and severe, until the point to call for a meeting with the parties concerned and plan the maintenance strategy for its intervention.

Figure 5. Direct Vibration and 1X response trend at Compressor Outboard Bearing.

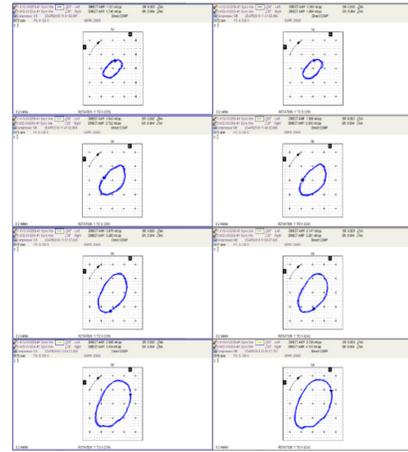
Notice how the orbit shape is being constantly modified (amplitude and phase angle) during the vibration event. The constant shift at the phase angle is easily identified by looking at the key-phasor mark (blank/bright spot). (Fig 6).

Figure 6. Sequence of changes noticed at the compensated orbit during the vibration increase.

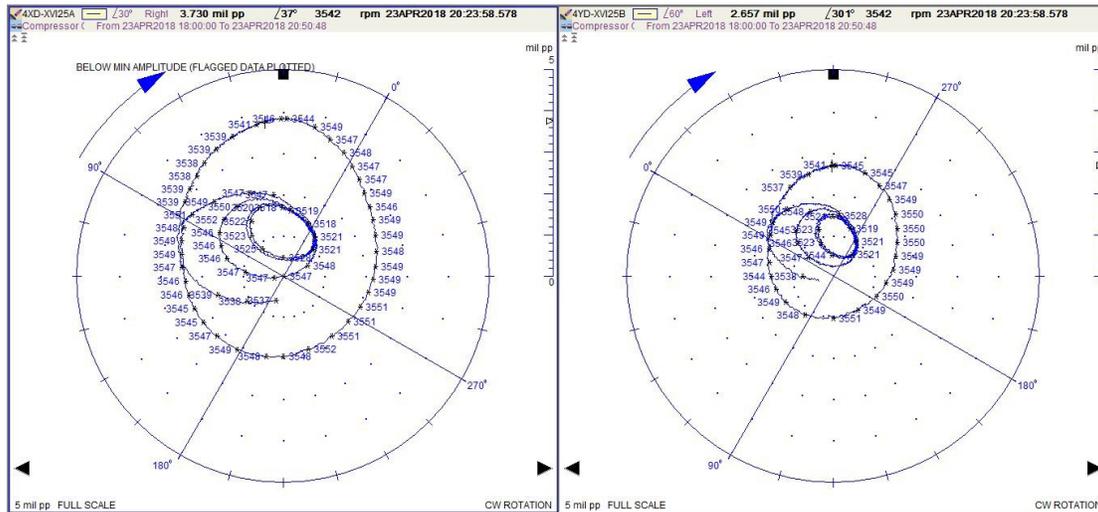
Polar plots collected at the compressor outboard bearing exhibits loops generated by continuous changes at the synchronous vibration response (1X) and phase angle. This information is revealing the symptoms of light rub. See figure 7.

Figure 7. 1X Frequency measured at the compressor outboard bearing.

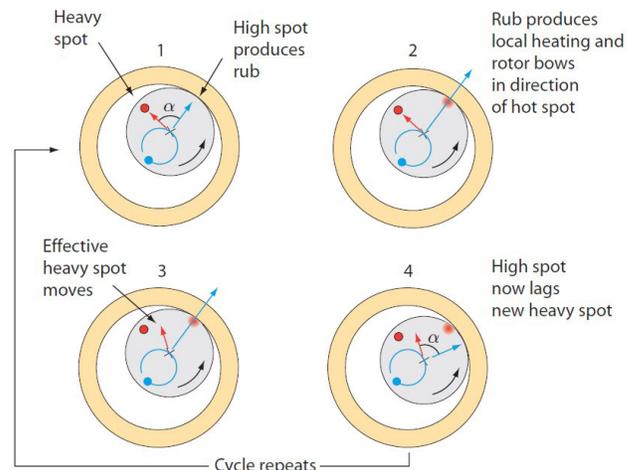
When a radial rub occurs, the heat generated from the frictional forces can locally heat up the rotor, causing it to bow, under this situation, the bow is seen as a change in 1X response, in the majority of the cases with no harmonics and subharmonics due to the friction type rub. With the correlation of the plots previously analyzed (Orbits, Polar, Full Spectrum), it is possible to identify the rub condition leading to shaft bowing.

Figure 8. Phenomenon of 1X rotating phase angle produced by a light rub.

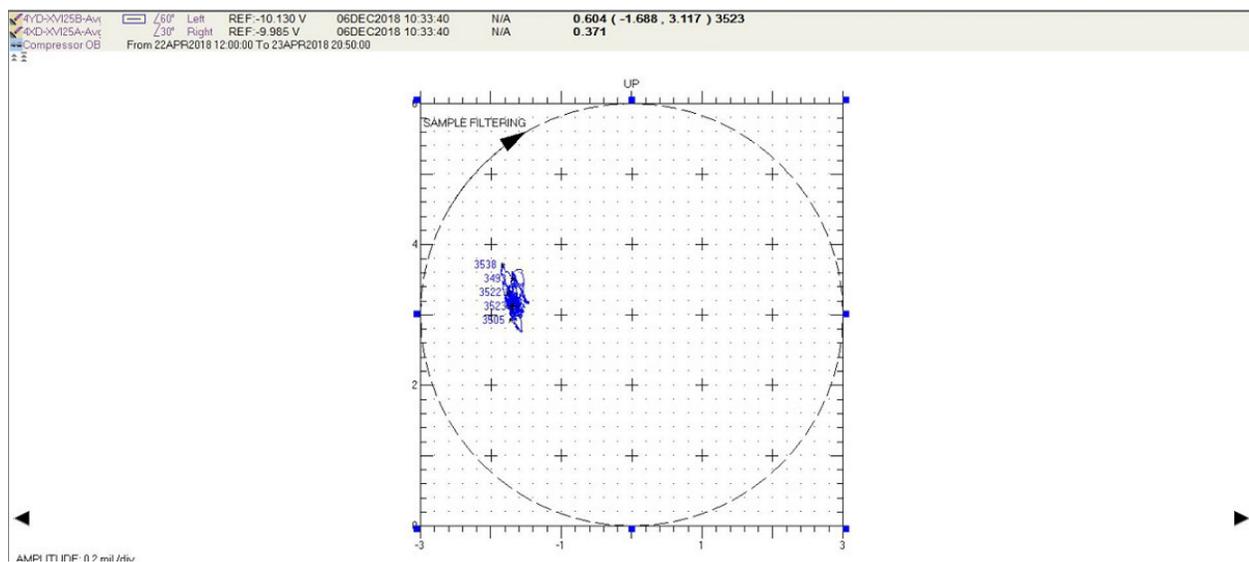
The contact between stationary and rotating parts take place during rubs, for this reason the shaft centerline (Fig-9) plot was also evaluated to verify any severe shaft deviation and discard any potential misalignment or any preload source that might be affecting the bearings or seals integrity.

At this occasion no major shaft movement was identified, even during the occurrence of the vibration increase, leaving room for the theory of oil contamination or carryover of foreign objects into the oil to the seal chamber.

A high possibility of presence of narrowed clearances was expected by accumulation of solid deposits, and as a consequence, to create heat enough between stationary and rotating parts, leading to a bowed shaft. Once the rubs get release the cycle start over and over again, producing the vibration changes studied through the plots.

Figure 9. Shaft centerline plot doesn't show any abnormalities.

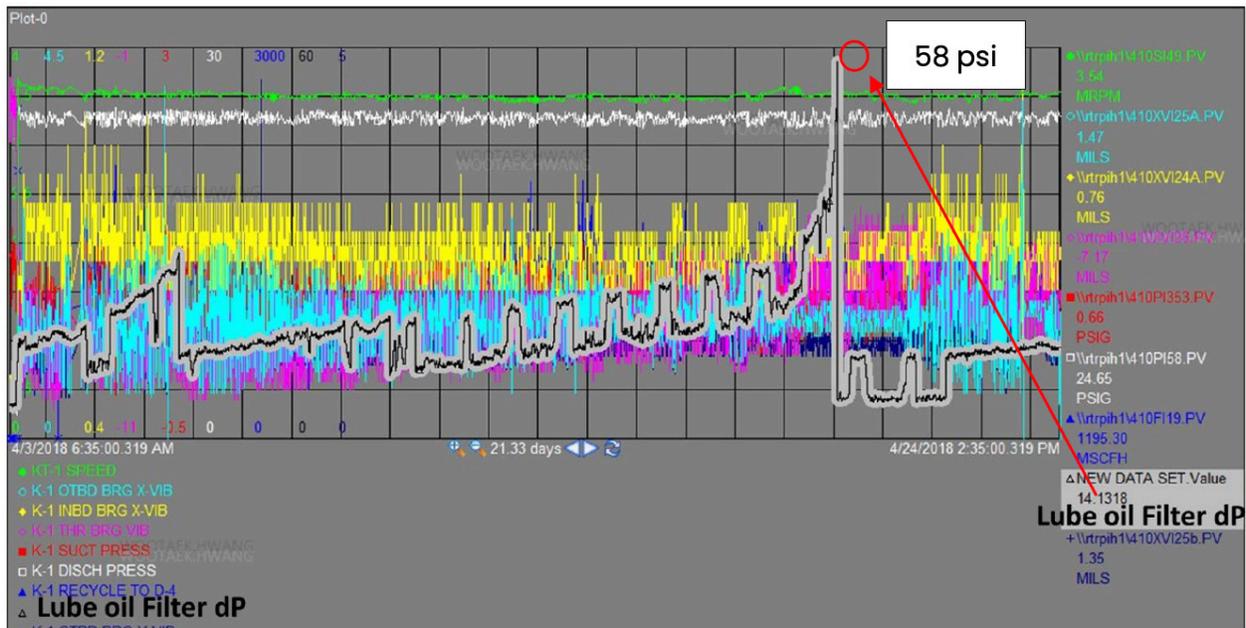
Due to an obsolete and off- specification design of turbine glands and oil system, the whole train is exposed to water contamination, and frequent plugging of lube oil filters with solid particles, as found during the site survey as per the graph in figure 10.

The maximum ΔP allowed by OEM is 15 psi and, in the graph, it can be observed how steps are being developed in the ΔP trend until it reaches more than 50 psi. (Fig 10).

Figure 10. PI trends showing the increase in ΔP at lube filters.

- The steam ejector of packing glands of the turbine driver has a higher back pressure than designed, and was not able to generate enough vacuum to prevent excessive steam leakage ingress into the bearing.
- The ventilation blower on the lube oil reservoir had reverse connection, which let dust atmosphere into the oil reservoir to contaminate the oil.

- For the Steam Ejector, there is an existing project to replace the compressor next year. Until then, it has been decided to increase the water drainage frequency to prevent the oil contamination by water.
- The ventilation blower connection has been corrected to avoid dust from atmosphere to ingress into the oil tank.

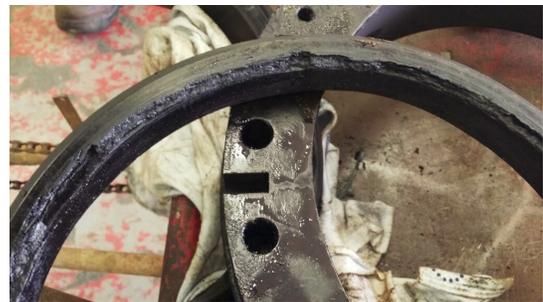
Site inspection revealed the deteriorated seal condition observed in the vibration plots as rub. The following pictures will show the real evidence of the high vibration values analyzed by the vibration group. Seal was found severely damaged around its circumference; radially (shaft) and axially (carbon ring faces) as it can be seen in figs 11, 12, 13 and 14.

Figure 12. Severe clogging of pollutant on carbon ring faces.

After performing the vibration analysis and identifying the possible sources of the vibration in the compressor, the rotating equipment crew recommended to replace both the mechanical ISO carbon seals to mitigate or eliminate the potential source of vibration in the compressor.

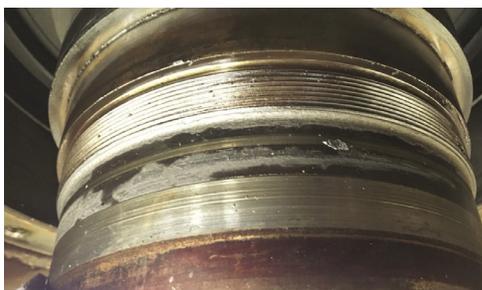
Figure 13. Shaft rub mark in the carbon ring area.

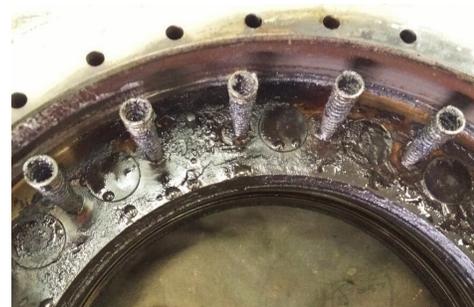
Figure 14. Varnish formation due to oil contamination.

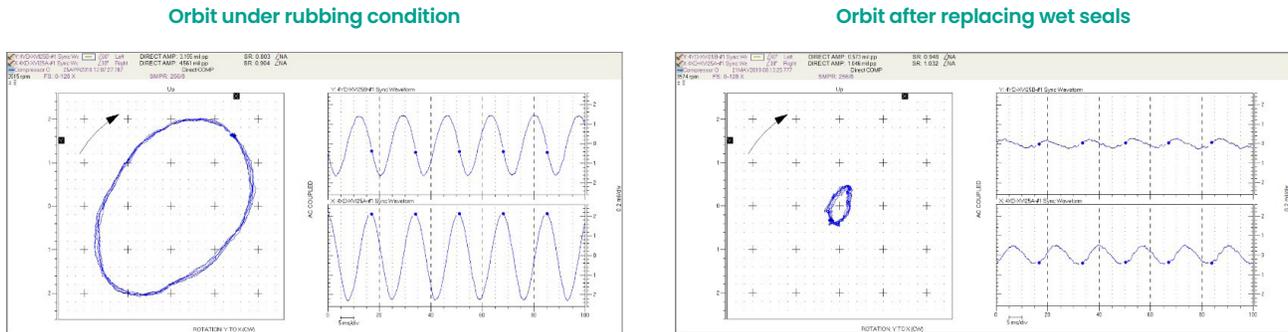
The compensated orbit plots indicate the positive result achieved after changing the seals in the scheduled maintenance window coordinated by the concerned parties. The vibration levels were improved significantly, as shown in comparing the values before the maintenance intervention and after the seal replacement. The orbit in the left represents the high vibration values during the rub, and the one on the right the normal vibration values.

Figure 15. Outboard Bearing Comparison Orbit Plot before and after the Repair.

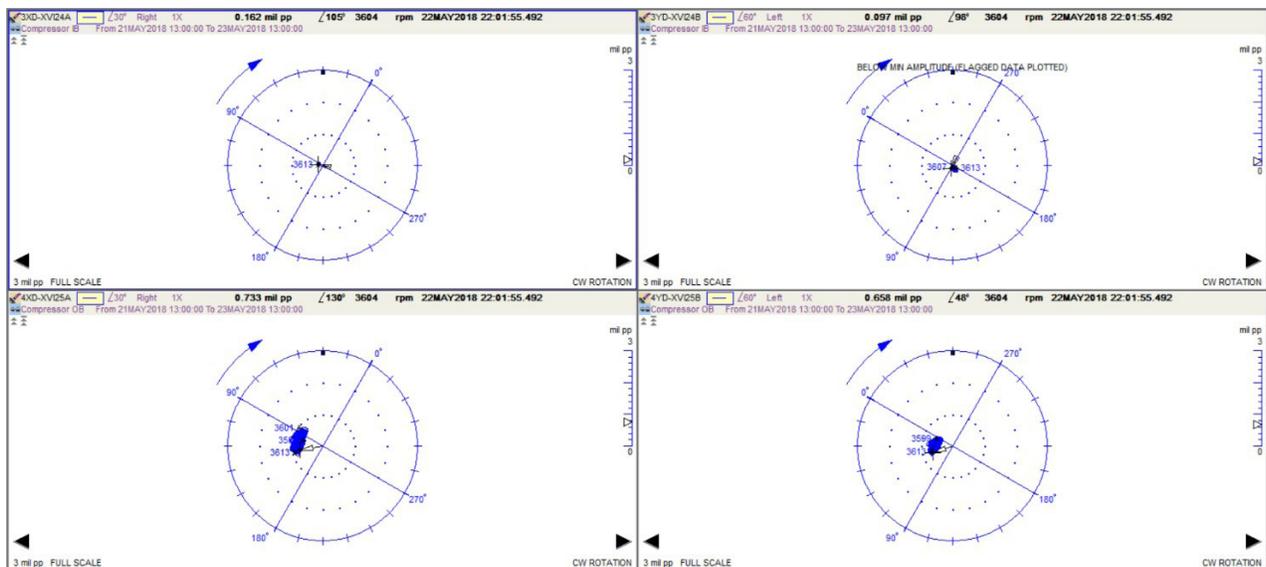
The 1X response is now steady and not moving 360 degrees as previous scenario. This comparison proves that the annular rub was eradicated from the compressor seals.

Figure 16. Polar plots at inboard and outboard bearing after the seal replacement.

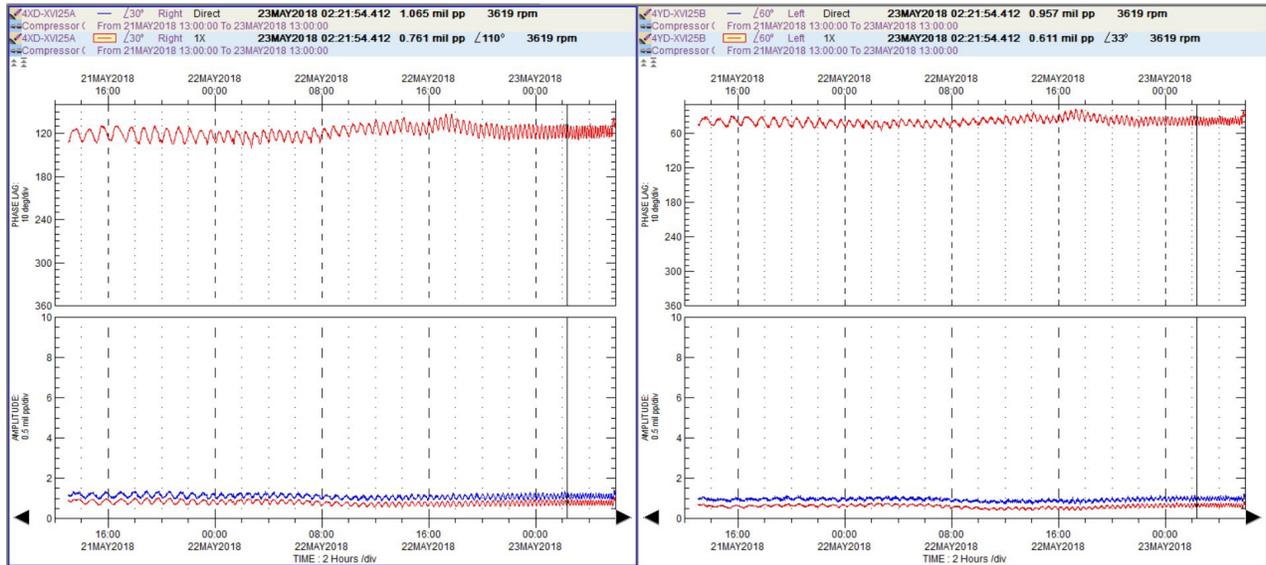
A 3-day trend was pulled out from the vibration data collector, to present the dynamic performance after implementing the seal replacement. The machinery behavior was improved with vibration within acceptable limits and a stable phase signal.

Figure 17. Outboard Bearing Overall and 1X vibration trend after the seal replacement.
