# Orbit Newsletter Digital Publication

Q4 2020

## Diagnostics of Steam Turbine High Vibration from Coupling Failure

Mr. Ryu, Joo Yong, Senior Manager, Korea Southern Power Co., Ltd.

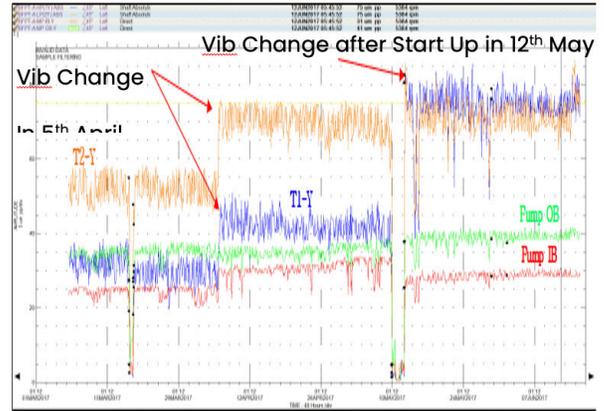
Figure 2: Bearing vibration trend

The initial sudden vibration level change was monitored at steam turbine T1 and T2 bearing (Table 2). One month later, an additional step change in vibration was observed after turbine shutdown/startup, especially evident with the 1X phase change. Table 3 shows history of 1X amplitude and phase change for 3 months. Figure 2 shows T1, T2 and Pump DE/NDE bearing direct vibration trend, T1 turbine bearing 1X vibration change is shown in Figure 3, and T2 turbine bearing 1X vibration change is shown in Figure 4.

Figure 2, vibration remained relatively steady after the first increase of vibration on April 5. However, after shutdown/startup of the turbine from May 10 to 12, vibration increased significantly. It was observed that turbine side vibration level changes were higher than pump side. Finally, the 1X vector at both turbine bearings (T1 and T2) reached up to 100 $\mu\text{m}$  pp after startup. Another interesting finding is that both T1 and T2 bearing 1X relative phase changes were out of phase. The increased 1X vibration response observed during the startup on May 12 is illustrated below (Figure 3 and 4).

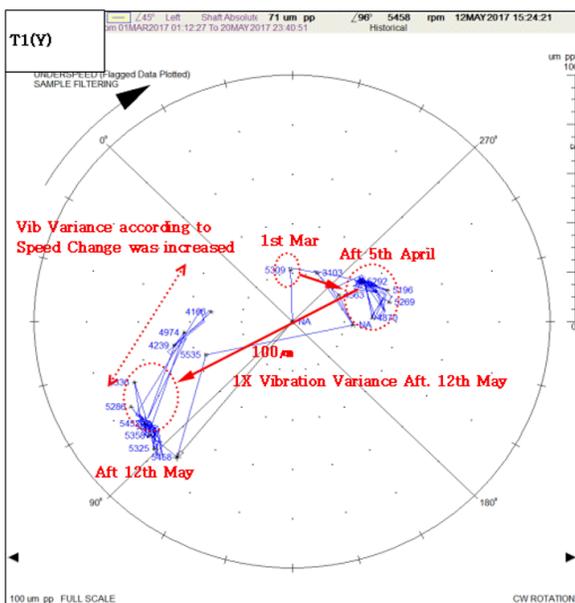
Figure 3: T1 bearing 1X vibration changing

Compared with previous transient response, after the startup on May 12, both T1 and T2 bearings' 1X vibration response became highly dependent on turbine speed. Further, the 1X vibration vectors at T1 and T2 have completely flipped by around 180 degrees each during the event.

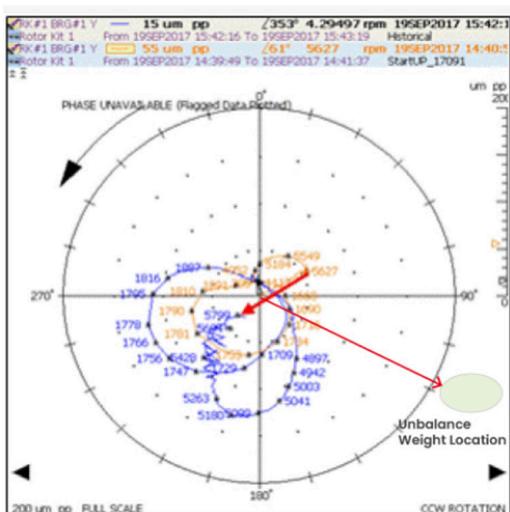
Figure 8: Rotor Kit #1 Bearing 1X transient vibration response (Yellow: baseline, Blue: Test weight attached)

The Rotor Kit shaft vibration response at each bearing, due to attached trial weight is shown in Figure 9 and 10. The yellow line is the baseline transient vibration response, and the blue line is vibration response when weight is attached. As a result, we can surmise that, in this case, unbalance in the coupling strongly affects the 2nd resonance mode, and the phase of vibration response at this speed is also significantly changed. Therefore, it can be safely stated that the observed vibration change in the feed pump turbine is most likely caused by unbalance of the coupling.

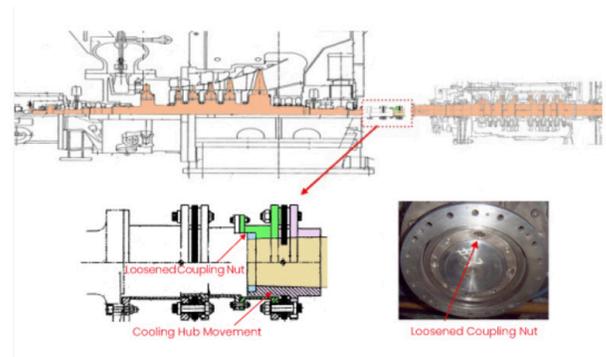
Figure 10: Position of loosened coupling nut

During the inspection, no crack or lost blade was found. However, looseness of pump side coupling nut was identified. The inspection result is shown in Table 4. The location of loosened coupling nut shown is in Figure 10.

The coupling was repaired by correctly fitting the taper at the right depth per manufacturer recommendation and fastening the retaining nut to the prescribed torque. As a result, vibration was reduced to normal. The vibration trend after coupling repair is shown in Figure 12.

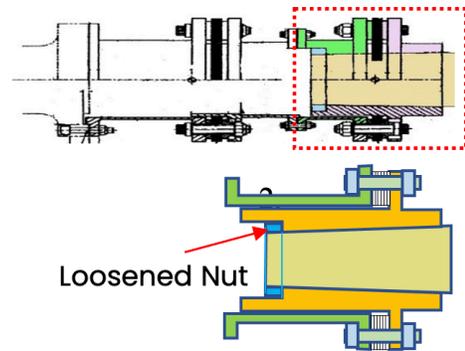
Figure 11: KOP-Flex Coupling

The coupling sleeve should be located to a proper depth on the tapered shaft and fastened by a nut. However, in this case it was found that the sleeve was not correctly installed, leading to looseness during operation. The loosened nut and coupling are shown in Figure 11.

The loosened nut allows the coupling to move in an axial direction, eventually resulting in unbalance of the coupling assembly.
