Orbit Newsletter Digital Publication

Production Gains in the Pulp Industry Using Wireless Sensors

Rone de Oliveira Silva, Vibration Analyst Reliability/Active Monitoring Center, Eldorado Brasil Celulose
João Siqueira, Field Application Engineer, Bently Nevada - Brazil
Três Lagoas - MS June 2020

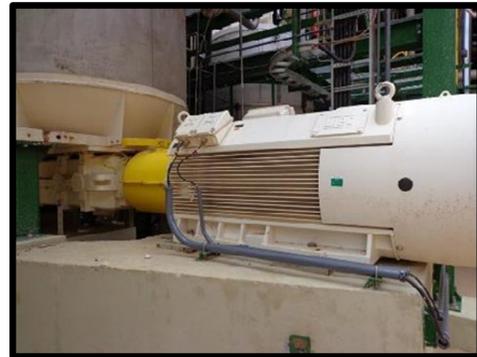
- Power: 710kW
- Voltage: 660V
- Speed: 1938 RPM
- Model: HGF 450
- Bearings: Rolling-element Bearing

Figure 4 – HGF450 motor image. Source: Eldorado Brasil Celulose

On 01/20/2020 the motor presented an exponential evolution in the vibration levels of the NDE bearing (Non-Drive End Bearing) with symptoms of mechanical clearance. Upon detection of a failure in a routine inspection, the Ranger Pro wireless sensor was installed to monitor the failure online, with much shorter collection intervals than the usual.

With this information, the managers were able to anticipate their actions for the replacement of the motor, in a scheduled way, performing the operational balance of the production area so that the operational flow of the plant was not greatly disturbed.

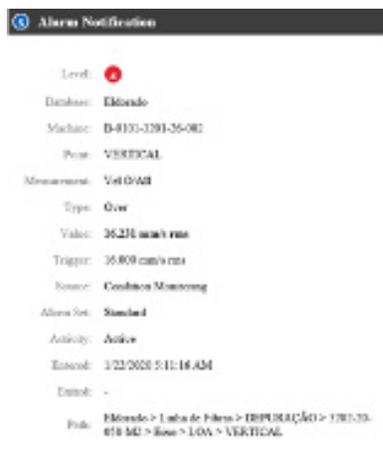
Figure 5 – System 1 alarm notification via e-mail. Source: The author

Already at dawn on 01/22/2020, the System 1 alarm management system identified an abnormal condition and automatically sent an e-mail to the maintenance team (at 5:11 am), warning the motor had reached critical vibration levels. See the picture on the left with the information sent by e-mail.

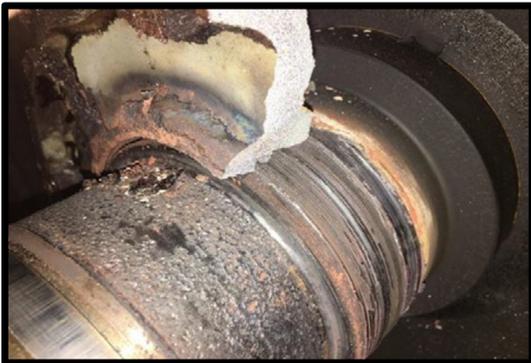
Figure 9 – Evidence of Motor Failure.
Source: Eldorado Brasil Internal Files

During motor maintenance, the failure identified in the analysis was confirmed. The lubricant seal cap of the bearing touched the shaft due to increased motor clearance, causing severe heating.

If the Eldorado maintenance team had not acted quickly, damage to the motor (rotor and other internal parts) would have been detrimental, which would have caused an increase in the repair cost, as well as the time needed to return the motor into operation negatively impacting plant operation availability index.

With this heating, the sealing cap had to be broken (picture on the left) to be removed and replaced with a new one.

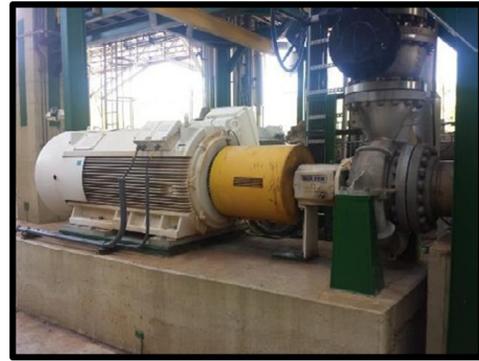
- Power: 670kW
- Voltage: 660V
- Speed: 1800 RPM
- Model: HGF 450
- Bearings: Rolling-element Bearing

Figure 10 – HGF 450 Motor.
Source: Eldorado Brasil Celulose Files.

On 12/21/2019 the motor presented an evolution in the PeakDemod (Peak) vibration levels, with symptoms of BPF (Ball Pass Frequency Inner Race) failure in the bearing on the opposite side of the coupling (NDE).

The operation team of this unit had a shutdown scheduled for 01/09/2020, and the challenge for the Asset Monitoring Center (AMC) team was to follow up and find ways to mitigate the effect of the failure until the scheduled shutdown date. This is a classic example of predictive asset maintenance.

The Ranger Pro sensor was used to track the evolution of the failure and to make decisions on actions to mitigate the effect of the failure, such as, occasional lubrication on this bearing.
