Orbit Newsletter Digital Publication

Q2 2020

Radial rub at centrifugal compressor's ISO carbon seals

Juan Carlos Ustiola, Vibration Specialist (CAT III)
Hwang Wootae, Rotating Equipment Engineer

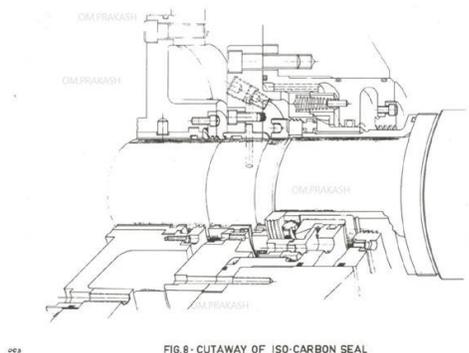
Figure 11. Seal drawing.

Site inspection revealed the deteriorated seal condition observed in the vibration plots as rub. The following pictures will show the real evidence of the high vibration values analyzed by the vibration group. Seal was found severely damaged around its circumference; radially (shaft) and axially (carbon ring faces) as it can be seen in figs 11, 12, 13 and 14.

After performing the vibration analysis and identifying the possible sources of the vibration in the compressor, the rotating equipment crew recommended to replace both the mechanical ISO carbon seals to mitigate or eliminate the potential source of vibration in the compressor.
